Manhole Inspection Summary

Manhole # S41K__020MH

Insp Date: **10/30/08 3:07 PM**

Location Address: **509 s eden st**

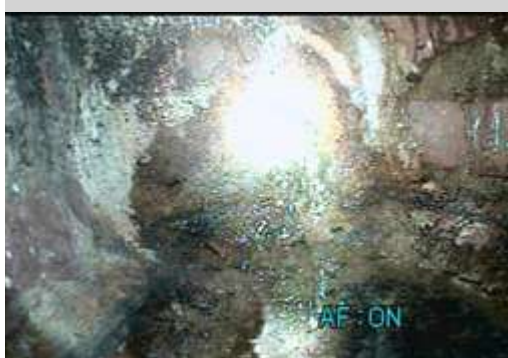
Additional Pipe In @ 3 OClock

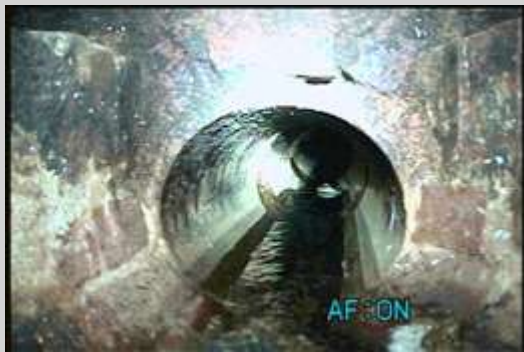
12 O'Clock Outflow

8 in. Circular Gravity Sewer
Pipe Out @ 12 O'Clock

Pipe Material: **Clay** ☐ Pipe Lined

Invert Depth: 8.20 (ft.) Flow Characteristics: **Slow**

Deposits: ☒ None ☐ Mud ☐ Sludge ☐ Debris ☐ Grease

Infiltration: **None** Pipe Seal Cond: **Unknown**

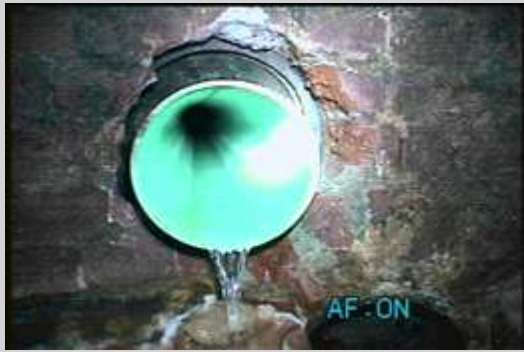
5 O'Clock Inflow

8 in. Circular Gravity Sewer

Pipe In @ 5 O'Clock

Pipe Material: **PVC** ☐ Pipe Lined

Invert Depth: **7.41** (ft.) Flow Characteristics: **Fast**

Infiltration: **None**

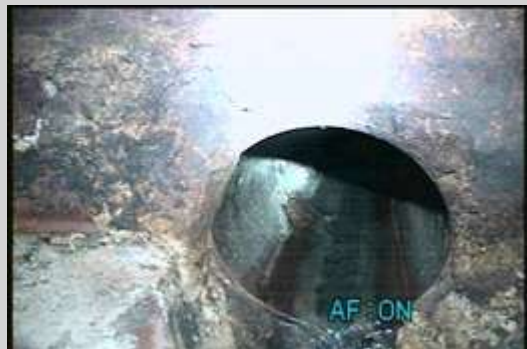
9 O'Clock Inflow

8 in. Circular Gravity Sewer
Pipe In @ 9 O'Clock

Pipe Material: **Clay** ☐ Pipe Lined

Infiltration: **None** Pipe Seal Cond: **Unknown**
